CUMBERLAND CONSERVATION DISTRICT

HISTORIC AREA PRESERVATION PLAN

HA-32 (CMB)

**A PART OF THE
COMPREHENSIVE PLAN
FOR MARION COUNTY, INDIANA**

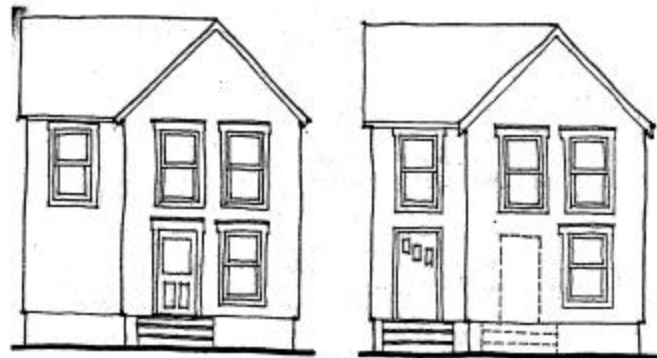
INAPPROPRIATE STORM DOORS

ORIGINAL

NOT RECOMMENDED

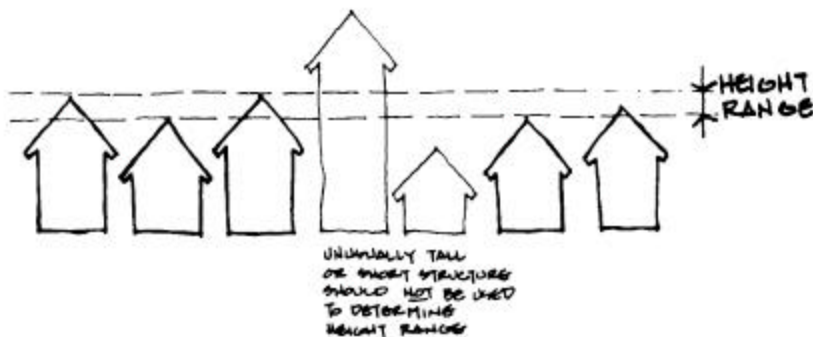
BUILDING OUTLINE: The silhouette of a building as seen from the street.

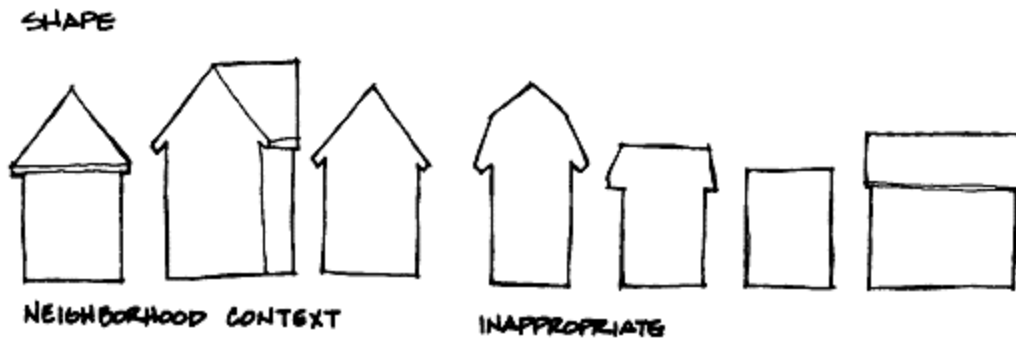
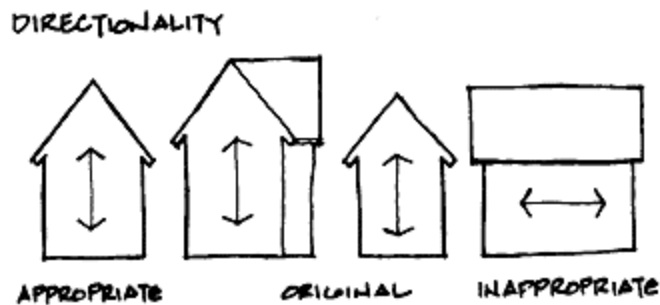
MASS: The three dimensional outline of a building.

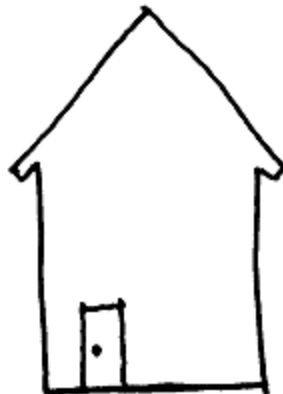
DOOR AT
GRADE

INAPPROPRIATE

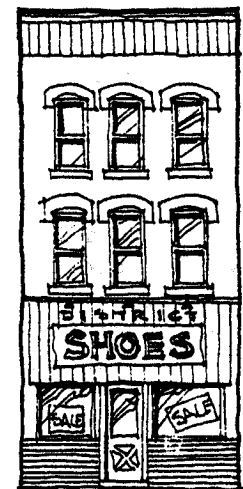
Inappropriate Placement
and Size

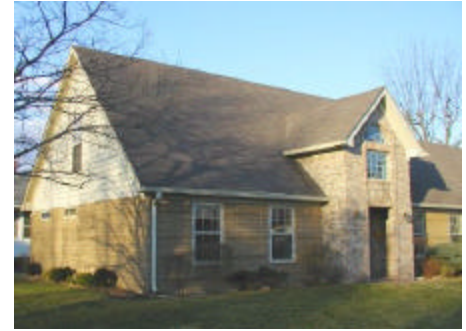
House
11801 Colmar St.
c. 1921
Contributing

Description: The 1956 Polk City Directory indicates Mrs. Matilda Wampner resided in the house.

This one-story pyramidal cottage features a low-pitched hipped roof with hipped dormers, a square building footprint, vinyl-clad walls, and an integrated full-width front porch. The house retains its original three and four-over-one wood windows and original front entry door with a glazed upper portion and wood paneled lower portion.

The 1-story bungalow at 11801 Colmar St., built c. 1920, exemplifies the visual sturdiness of the Craftsman style that appears in many homes of the period. The rough-faced block foundation supports vinyl-clad exterior walls that meet the roof junction in narrow overhanging eaves. The hipped roof has two hipped dormers with small three-unit ribbon windows. The west side of the house has a narrow bay with a large three-unit ribbon window. The solid brick balustrade and support columns of the front porch add to the aura of indestructibility of the home. The double-hung windows are glazed three or four lights in the upper sash and a single light in the lower sash. Obscured by a wooden storm door, the main entry door is original with a glazed upper portion and a wood paneled lower portion.

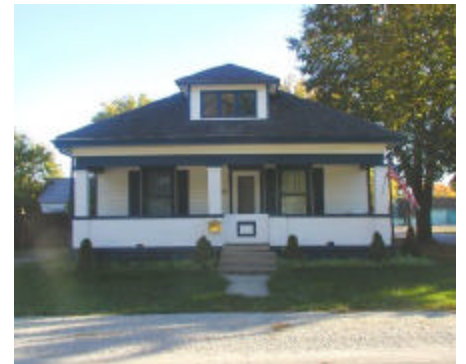
House
11809 Colmar St.
c. 1900
Contributing

Characteristic of hall-and-parlor structures, this simple side-gabled house is a folk form derived from colonial era housing. The house is 1-story, covered by aluminum siding, and retains all of its original wood windows. The wing on the east elevation is a later addition, and the porch was modified c.1950. Although some minor changes were made, this structure is almost wholly intact and remains an excellent example of vernacular architecture.

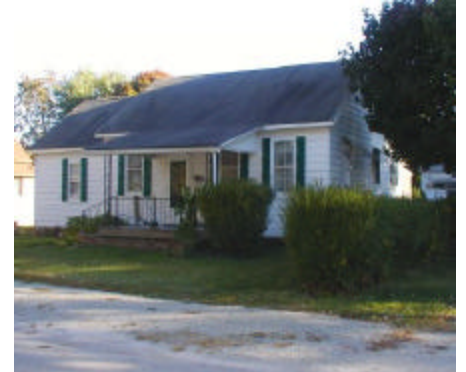
House
11817 Colmar St.
c. 1890
Contributing

This 1½-story L-plan house has a cross-gabled roof, artificial siding, and one-over-one windows. Although not original to the structure, a porch with a shed roof protrudes from L made by the two wings.

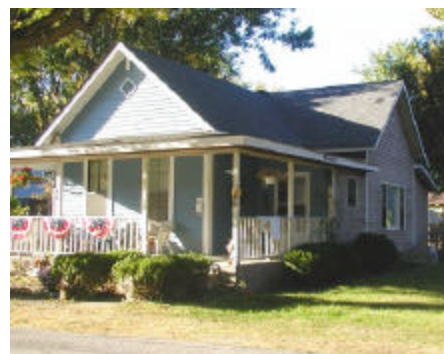
Sanders-Caylor House
11825 Colmar St.
c. 1850
Contributing

The Sanders-Caylor house is a 1½ story side-gable house that is representative of a "hall-and-parlor" type structure (two rooms wide by one room deep). The house has a steeply pitched side gabled roof, an asymmetrical front façade with an off-center door, long narrow windows, and a small porch stoop at the front entryway. An ell extends from the rear elevation and was presumably added after the house was built to provide more living space.

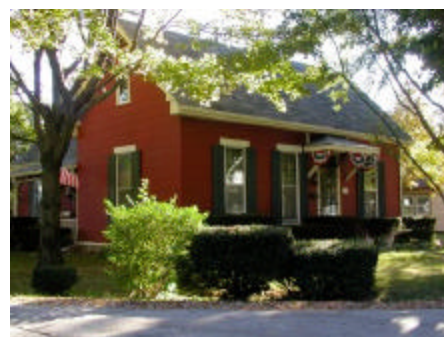
House
11900 Colmar St.
c. 1900
Contributing

This 1-story house has a modestly-pitched cross-gable roof, vinyl wall

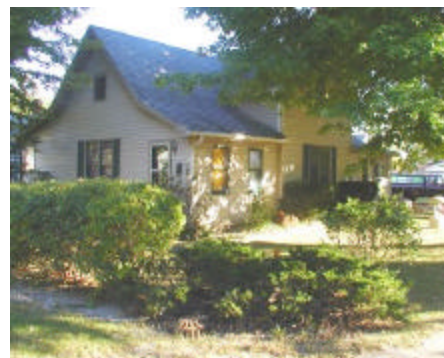
Prickett House
11907 Colmar St.
c. 1900
Contributing

Description: In the 1950s, this house's property owners were Edward Pete A. & Velma Prickett. Mrs. Prickett continues to own and occupy the house today.

The 1-story, gable front and wing Folk Victorian house at 11907 Colmar St. is another variation on the basic style and has been modified by adding a small wing on the east side and a shed roof addition to the rear. The modifications appear to be early in the life of the building, built c.1900, and demonstrate the evolution of many of the small homes in the district – as the family grew, so did the house. From a brick foundation, the wood clapboard exterior siding extends upward to simple moderate eaves overhangs supported at the corners by scroll brackets. Vertical board siding highlights the infill of the gable ends; the lower ends of the boards are staggered in a saw tooth pattern. A small square ventilator is centered in each gable. On the front façade, the gable peak is accentuated by a decorative cross bracing reminiscent of the Gothic Revival style. A low silhouette brick chimney rises from the center of the roof at the intersection of the wing and front gable. The small shed roof porch in the ell is decorated with spindle work and board siding in the saw tooth pattern. The one-over-one, double-hung windows throughout the house appear original, and the surrounds typify those seen in other Folk Victorian houses. The doors are original, single-glazed in the upper half and wood paneled in the lower half.

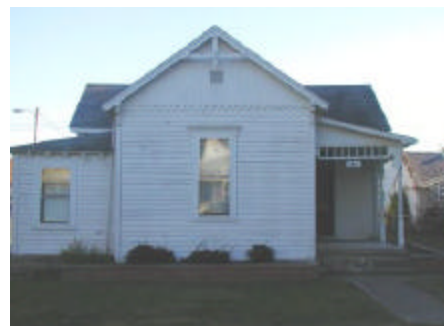
House
11908 Colmar St.
c. 1890
Contributing

Representative of folk Victorian architecture, the exterior of this 1½-story T-plan house has experienced few alterations since its time of construction. The house has a brick foundation, cross-gable roof, wood clapboard siding, one-over-one wood windows, and a small side porch. Ornamental "stick style" elements embellish the house, including decorative scroll brackets under the eaves, vertical picket fence siding across the front gable end, a King's post truss, and turned porch supports.

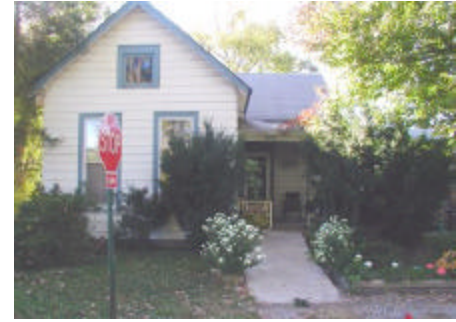
Description: The 1956 Polk City Directory indicates Byron A. Limbach resided here.

This small one-story T-plan house is typical of a folk Victorian cottage. The house has a cross-gabled asphalt shingle roof, aluminum siding presumably over wood clapboard, and long narrow one-over-one windows.

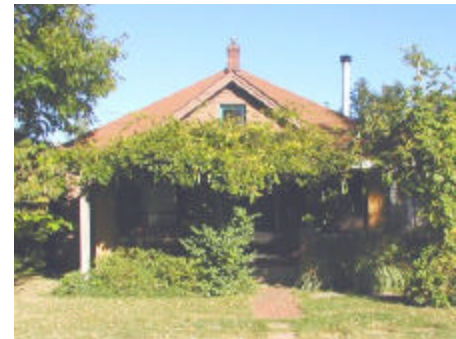
House
101 S. Heflin St.
c. 1890/c.1920
Contributing

Description: The 1956 Polk City Directory indicates Clarence O. Green resided here. Also, at one time, the house was owned by Bill and Bertha Hilkene.

This one-story pyramidal cottage was built c.1890. However, around 1920, the house was renovated and many Arts & Crafts details were added. The house features a low-pitched hipped roof with a central chimney and a central front-gable dormer, a square building footprint, aluminum siding, and an integrated full-width brick front porch.

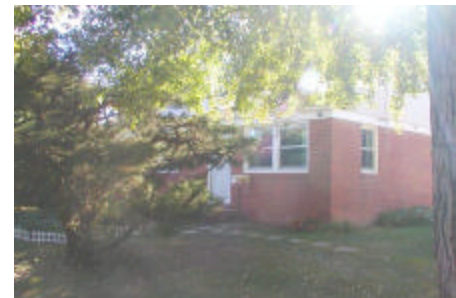
House
102 S. Heflin St.
c. 1960
Non-Contributing

Description: Historically, a frame house occupied this lot but was destroyed or removed sometime before 1956. The 1956 Sanborn map depicts a vacant lot on this site.

The existing structure is similar to house at 116 S. Heflin St. This 1-story minimal-ranch style house has a low-pitched roof, brick veneer wall cladding, paired windows on the front elevation, and a traditional wood door.

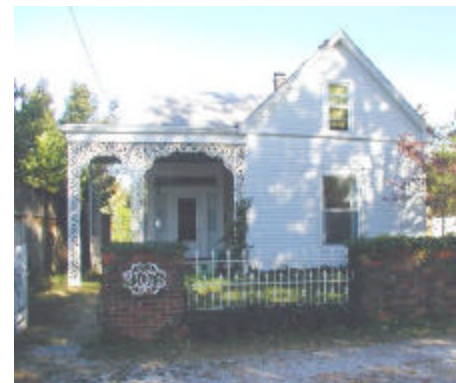
House
107 S. Heflin St.
c. 1900
Contributing

Description: This 1½ -story gabled-ell house has a cross-gabled roof, vinyl wall cladding, and one-over-one windows. Around 1960, decorative ironwork was added to the front porch, presumably replacing the original wood porch supports. In addition, a decorative brick and wrought iron fence was installed in the front yard.

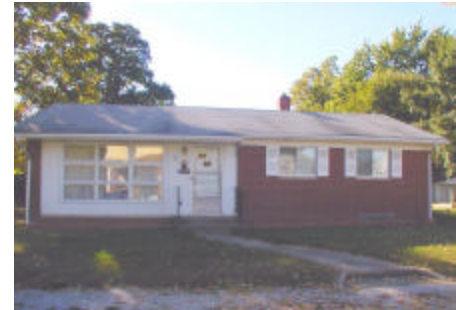
House
116 S. Heflin St.
c. 1960
Non-Contributing

Description: Similar to the house at 102 S. Heflin St., this minimal ranch style house has a low-pitched side gabled roof, brick veneer wall cladding, large picture window on the front elevation, and a traditional wood door.

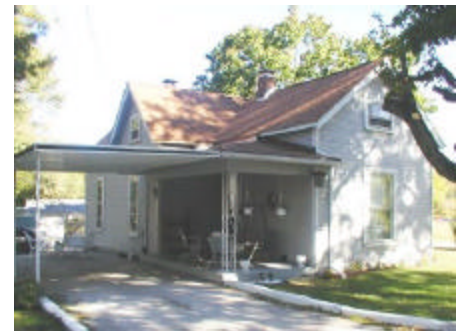
House
215 S. Heflin St.
c. 1890
Contributing

Description: Historically, the Cumberland Courier Newspaper Company operated its business at the rear of this property. However, the newspaper building was destroyed by fire. All that remains today is a large concrete pad in the rear yard.

This existing house was constructed around 1890. The 1½-story T-plan house has a cross-gabled roof, vinyl wall cladding, and one-over-one windows. The roof structure over the front porch and the carport were later modifications.

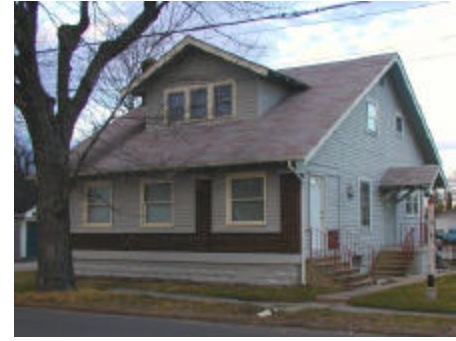
Schutt House
30 N. Muessing St.
c. 1890
Contributing

This 1½-story house is a dormer-front Craftsman style bungalow. Defining architectural features include a low-pitched side-gabled roof with a central front-gable dormer, artificial siding, one-over-one windows and a cast stone foundation. The house originally had an open full-width brick front porch, although it was later converted into an enclosed living space.

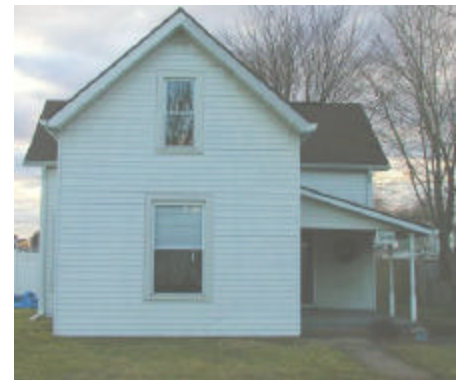
House
40 N. Muessing St.
c. 1890
Contributing

This 2-story house has a cross-gabled roof, vinyl wall cladding, one-over-one windows, and a shed roof porch. Although some historic materials were replaced, the house retains its original shape and dimensions.

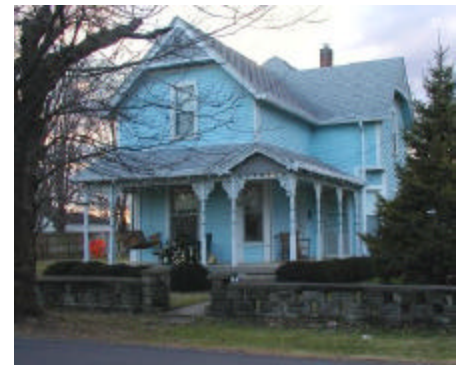
This 2-story house is a significant example of Queen Anne style architecture in Cumberland and retains a great deal of its historic integrity. The house features a steeply-pitched cross-gabled roof, asymmetrical facades, original wood clapboard siding, and one-over-one double hung wood windows. One of the most defining characteristics of the house is its elaborate wrap-around front porch that features ornate wood porch supports and decorative brackets and spindlework. Another unique and significant site feature is the stone fence, laid in a honeycomb pattern, which runs along the front property line.

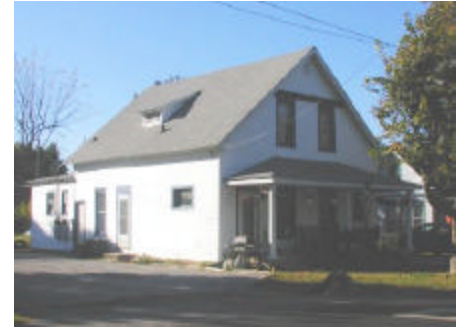
House
100 N. Muessing St.
c. 1910
Contributing

Description: This 1½-story gable-front double house has a steeply-pitched front gable roof with side dormers, symmetrical façade, vinyl wall cladding, and a full-width shed roof front porch. It is unknown when the rear addition was constructed.

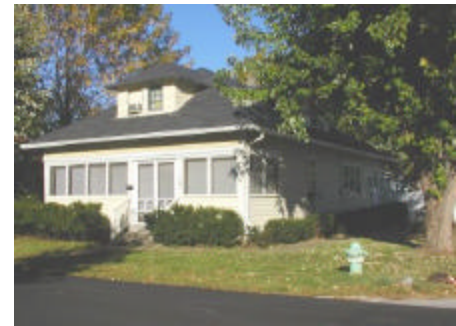
House
101 N. Muessing St.
c. 1920
Contributing

Description: This simple one-story pyramidal cottage was built c.1920. The house features a low-pitched hipped roof with a central dormer, a square building footprint, contemporary siding, and an integrated and enclosed full-width front porch. Most likely the porch was open when the house was first constructed and then later enclosed.

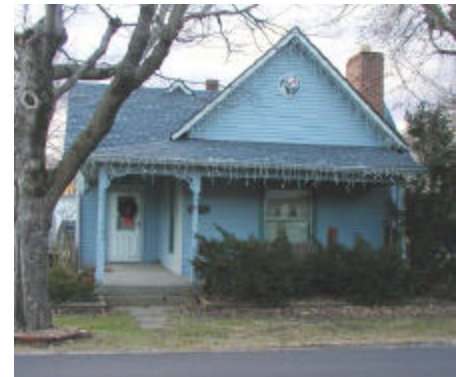
House
108 N. Muessing St.
c. 1910
Contributing

This one-story Queen Anne style cottage has a steeply pitched cross-gable roof, wood clapboard siding, one-over-one windows, a large chimney, and a full width porch that extends along the front and side of the house. Decorative scroll brackets and turned porch supports are characteristic of the Queen Anne style.

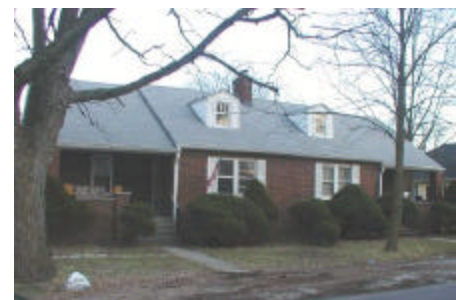
House
109-111 N. Muessing St.
c. 1940
Contributing

The double house features a symmetrical façade, and each half of the double is a mirror image of itself. The house has a side gable roof with two front gable dormers, central chimney, brick veneer wall cladding, and paired one-over-one double hung windows. The entryways are located on the north and south ends of the house and include integrated front porches.

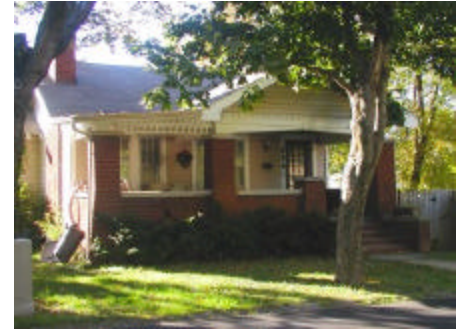
House
124 N. Muessing St.
c. 1910
Contributing

This 1½-story Craftsman style house features a brick foundation, vinyl clad exterior walls, a cross-gabled roof, wide overhanging eaves, and a brick full-width front porch. Craftsman style detailing includes wide fascia boards with flared ends and three-over-one double hung wood windows.

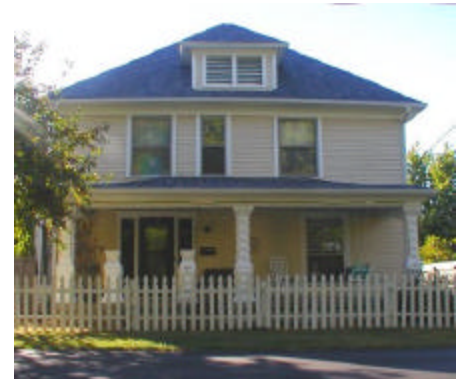
This 2-story house is characteristic of the American Foursquare style. It has a low-pitch hipped roof with a central dormer, original wood clapboard siding, one-over-one double hung wood windows, and original full-view front entry door and sidelights. The house features a full-width front porch that has cast-stone porch supports.

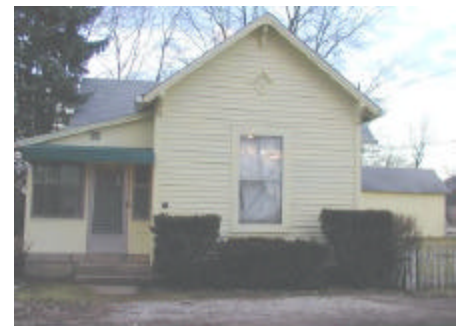
House
25 S. Muessing St.
c. 1895
Contributing

Representative of folk Victorian architecture, the exterior of this 1-story T-plan house has experienced few alterations since its time of construction. The house has a cross-gable roof, wood clapboard siding, one-over-one wood windows, and a small enclosed side porch. The porch was enclosed prior to 1956. The house has decorative eave brackets and an attic vent on the front elevation.

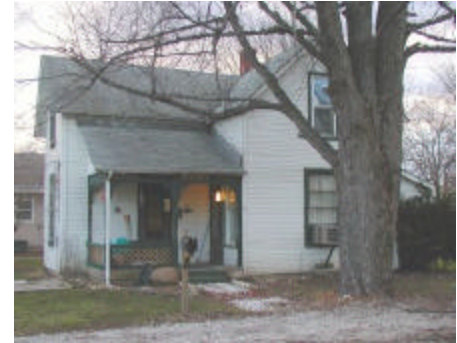
Description: This structure was originally located at 11701 E. Washington St. When the American Fletcher National Bank was constructed, the house was moved to accommodate the bank building. At one time, Bill and Bertha Hilkene owned the house.

This 1½-story T-plan house is indicative of folk Victorian architecture. It has a cross-gable roof, wood clapboard siding, wood windows, and a shed roof porch. Victorian-style elements embellish the porch, including decorative wood porch supports and spindlework.

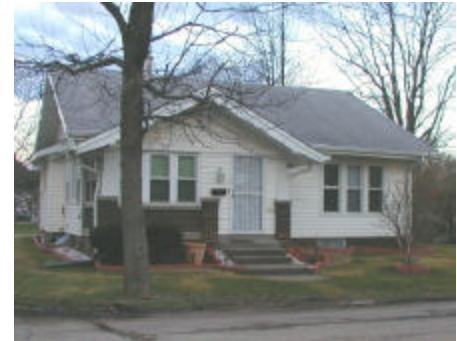
House
101 S. Muessing Street
c. 1925
Contributing

This 1-story house is representative of the Minimal-Traditional style. While the house appears to be modeled after older vernacular house (L-plan), it displays post-war building materials and features. The house has a low-pitched side-gable roof, a front-gable partial-width front porch, and displays only minimal decorative detailing.

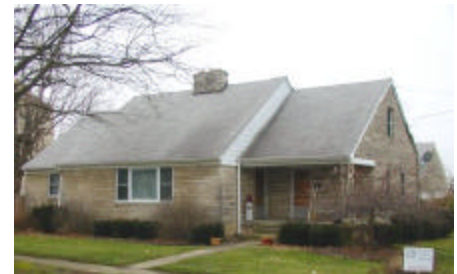
Parsonage – Cumberland Baptist Church
116 S. Muessing Street
c. 1945
Contributing

Description: This post-war Cape Cod style house has a side-gable roof, limestone veneer wall cladding, metal windows and period wood doors. The front elevation has a large picture window flanked on either side by a one-over-one window, and a small integrated porch is located on the north end of the house.

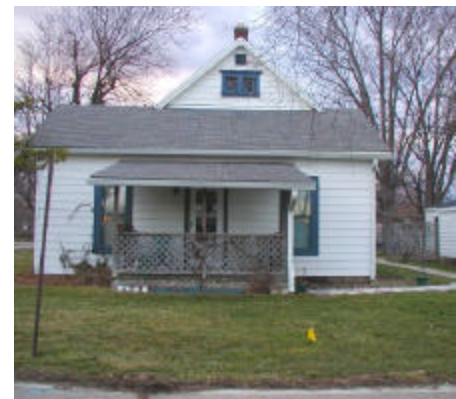
House
199 S. Muessing Street
c. 1885
Contributing

Description: The architectural evolution of this house is unclear. However, the Saxon St. elevation may have been an earlier “hall-and-parlor” type structure (two rooms wide by one room deep). It appears the Queen-Anne style addition was a later modification.

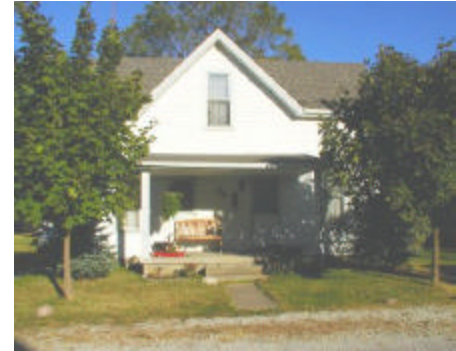
House
33 N. Munsie St.
c. 1890
Contributing

Description: This simple 1½-story side-gabled house is derived from a basic folk form of housing. Although once a popular architectural style, few such houses remain today. This house has a symmetrical façade, aluminum clad walls, long narrow windows, a double entry, and a full width front porch.

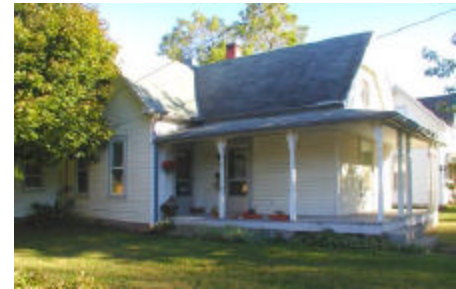
House
39 N. Munsie St.
c. 1890
Contributing

Description: This 1½-story house is characteristic of Folk Victorian architecture and is accentuated by Queen Anne style detailing. The house has a cross-gable roof, wood siding, one-over-one windows, and a full width porch that extends along the front and side of the house. Decorative scroll brackets and Queen Anne style turned porch supports embellish this otherwise simple house.

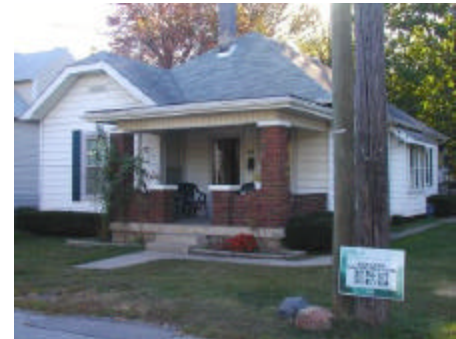
House
102 N. Munsie St.
c. 1915
Contributing

Description: This 1½-story house appears to be a hybrid between a gable front-and-wing and a side-gabled Craftsman style house. The house features a rough-faced block foundation, asbestos shingle clad exterior walls, and one-over-one double hung sash wood windows. The partial-width front porch is built of cobblestone with mortared joints.

The 1½-story house at 102 N. Munsie St., built c.1915, appears to be a hybrid, with elements of a gable and wing and a purely side gable design evidenced in the final construction. The asbestos shingle-clad exterior walls are supported by a rough-faced block foundation. The relatively narrow boxed eaves of the moderately pitched roof end in flared lower ends. Centered over the porch on the east side of the roof is a prominent gable dormer with small, paired windows. The front facing gable of the wing has a large center window with flanking sidelights on the first floor, and a single window in the half story. The front porch balustrade and roof support columns are constructed of cobblestones with mortared joints. The one-over-one, double-hung windows are original; the surrounds have flat sides and milled drip caps. The entry door is not original and appears to be of 1950s vintage.

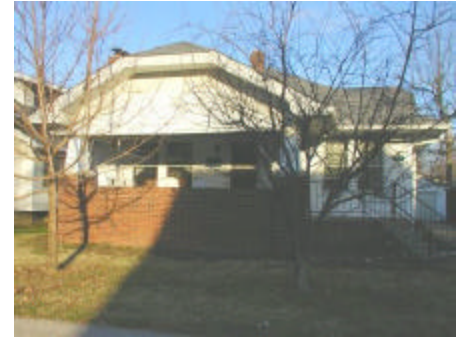
House
113 N. Munsie St.
c. 1915
Contributing

Description: This 1½-story house is representative of the Arts & Crafts style. The house has a low-pitched front-gable roof with wide, unenclosed eaves, shed-roof side dormers, and decorative eave brackets. A full-width brick porch, built upon a cast stone foundation, spans the front elevation. The walls appear to be covered by contemporary siding.

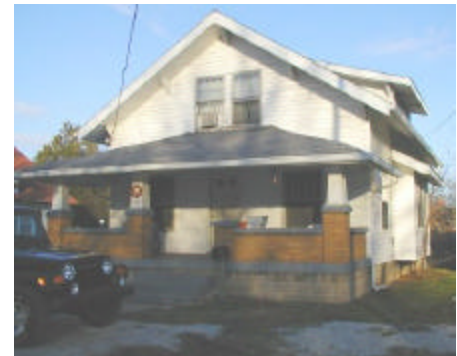
House
119 N. Munsie St.
c. 1915
Contributing

Description: This 1½-story Craftsman-style California bungalow is characterized by its front-gable roof and full width front-gable porch. The house appears to have been modernized in the 1950-60s, and was clad with contemporary siding and shutters were added.

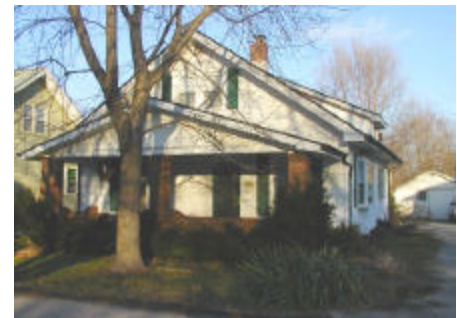
House
120 N. Munsie St.
c. 1915
Contributing

Description: This 1½-story front-gable house features a rough-face block foundation, wood clapboard siding, one-over-one double hung sash wood windows, half-glass wood doors, and a full width front porch with brick porch supports and brick balustrade. The steeply pitched roof has dormers on the north and side elevations and appear to be original.

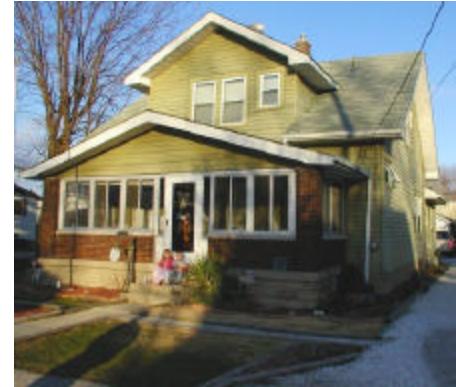
House
126 N. Munsie St.
c. 1920
Contributing

Description: This 1½-story Craftsman-style bungalow has a low-pitched front-gable roof with wide, overhanging eaves, decorative knee-brace eave brackets, wood clapboard wall siding, and one-over-one windows. A full-width brick porch, which rests upon a cast stone foundation, spans the front elevation.

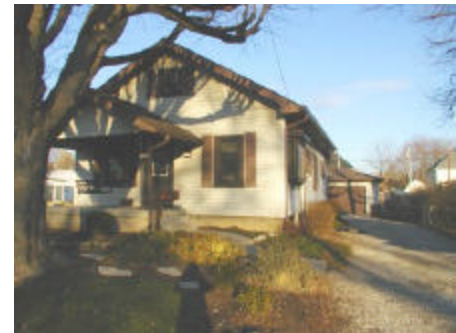
House
133 N. Munsie St.
c. 1920
Contributing

Description: Built as a modest Bungalow, this 1½-story house has a low-pitched front-gable roof, vinyl clad walls, replacement windows and doors and replacement porch supports. A later addition was constructed on the rear elevation.

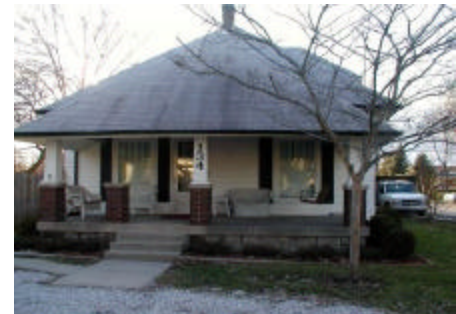
House
134 N. Munsie St.
c. 1914
Contributing

Description: This 1-story pyramidal cottage features a low-pitched hipped roof with side dormers, an integrated full-width front porch, an off-center front entry door, and two large Craftsman-style windows on the front elevation.

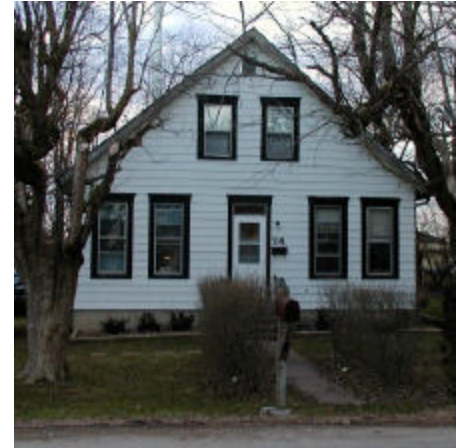
Description: This house, historically owned by Fred and Hannah Weise, was originally located at 11635 E. Washington Street. The house was moved to its present location to make room for a Gulf Gas Station (now an automotive repair shop).

The Weise House is a 1½-story gable front house with a steeply-pitched roof and a symmetrical façade. Two one-over-one windows are located on each side of the central front entry door and two windows are also located above. The exterior walls are clad with aluminum siding, which presumably covers the original wood clapboard.

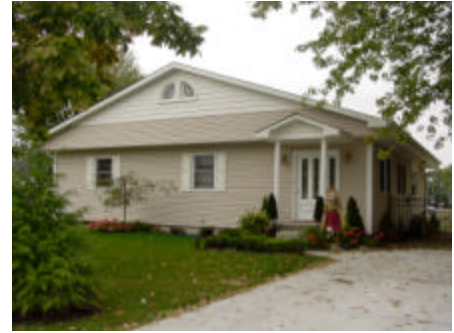
House
11720 Saturn St.
c. 2000
Non-Contributing

Description: This 1-story house has a low-pitched front gable roof, vinyl clad walls, vinyl one-over-one windows, and an off-center front entry way. A small portico is located over the front door.

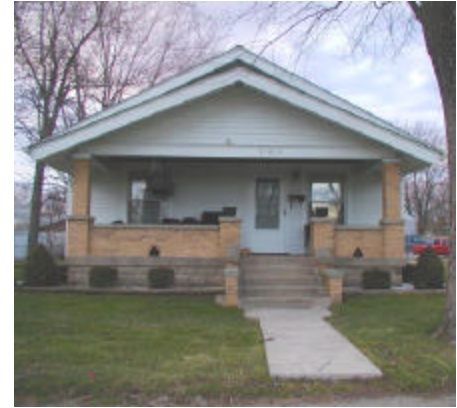
House
11810 Saxon St.
c. 1920
Contributing

Description: This 1½-story Craftsman-style California bungalow is characterized by its low-pitched front-gable roof and full width front-gable porch. The house has an off-center front entry door, flanked by two windows, and a brick porch spans the front elevation.

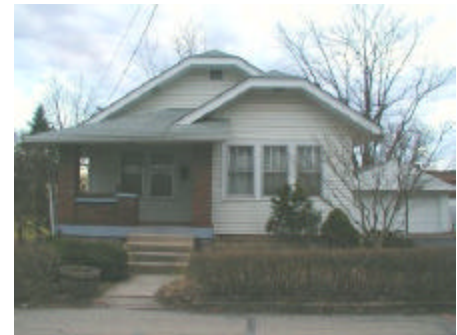
House
11815 Saxon St.
c. 1915
Contributing

Description: Representative of the Craftsman-style, this 1-story bungalow has multiple front-gable roofs with clipped gables, three-over-one Craftsman-style wood windows, an integrated partial-width brick front porch, and a cast stone foundation.

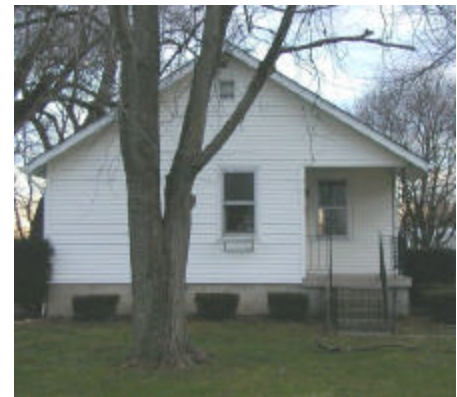
House
11901 Saxon St.
c. 1935
Contributing

Description: Having only minimal detailing, this 1-story house has a front-gable roof, contemporary wall cladding, one-over-one windows, and a small, integrated front porch. There is a later addition that was constructed on the rear elevation.

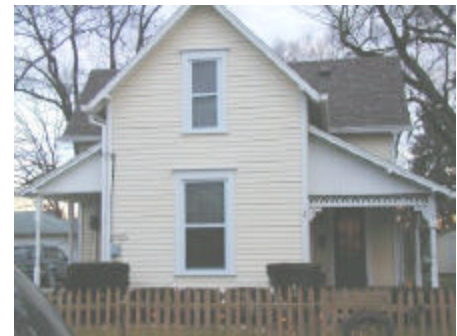
Amos House
11907 Saxon St.
c. 1890
Contributing

Description: The Amos House is a 1½-story T-plan house built in the folk Victorian style. The house retains many of its original building elements, including wood clapboard siding, one-over-one double hung sash wood windows, and two Queen Anne style shed roof porches with decorative turned porch supports and spindlework.

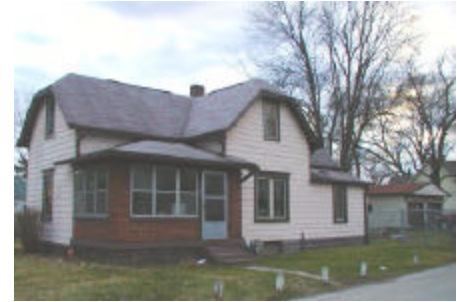
House
11929 Saxon St.
c. 1900
Contributing

Description: This 2-story house has a cross-gable jerkinhead roof, aluminum wall cladding, and one-over-one windows. The partial width front porch was most likely built around c.1915 and then later enclosed. Presumably, the house originally had a wood porch.

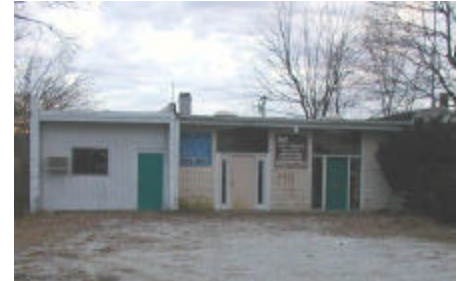
Commercial Building
12003 Saxon St.
c. 1960
Non-Contributing

Description: This modern 1-story commercial structure has a rectangular footprint, a flat roof, and has a variety of exterior wall cladding materials, including concrete block, vertical wood siding, stone veneer, and sheetmetal.

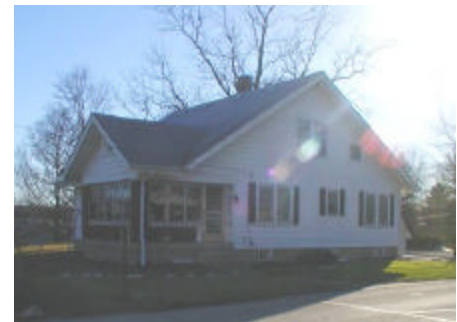
House
12019 Saxon St.
c. 1915
Contributing

Description: Built in the Craftsman style, this 1½-story bungalow features a moderately-pitched side gable roof, cast stone foundation, aluminum wall cladding, and one-over-one windows. A partial width brick front porch, with a front gable roof, spans the front elevation. Today, the porch is enclosed, although it was presumably open when first constructed.

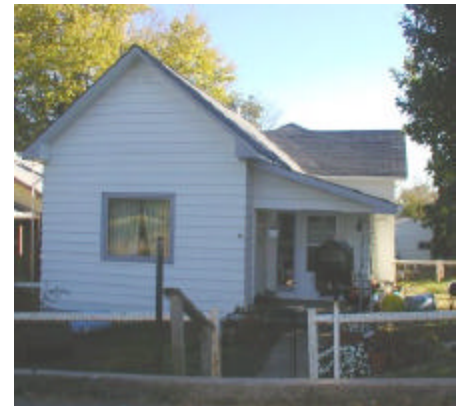
House
12041 Saxon St.
c. 1900
Contributing

Description: Exhibiting only minimal detailing, this 1-story Folk Victorian cottage has a cross-gable roof, artificial siding, one-over-one windows, and a small, shed roof side porch. Over the years, the house has endured some modifications including the window opening on the front elevation, the shed roof covering the porch, and the doors.

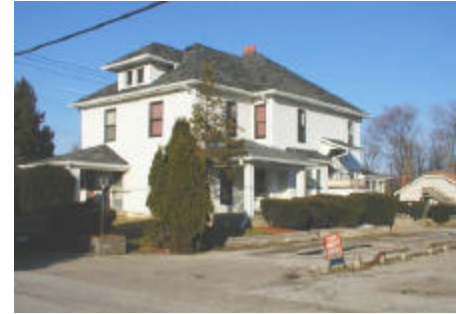
Meier House
23 N. Starter St.
c. 1910
Contributing

Description: Henry “Heinie” Meier constructed this house around 1910. Mr. Meier was a prominent and very active Cumberland resident and was the owner of Meier’s Food Market, located on the National Road. This house was originally located at 12010 E. Washington St. (parcel # 7001541) but was moved to make room for Mr. Meier’s grocery store. Cumberland’s first kindergarten was held in the basement of this house. Today, it serves as a multifamily residence.

The Meier House is a large American Foursquare style house that exhibits minimal neo-classical detailing. The house has a low-pitched hipped roof with a central front dormer, a mostly rectangular footprint, and one-over-one windows. Partial width porches, accented by fluted column porch supports, are located on the front (west) and side (south) elevations.

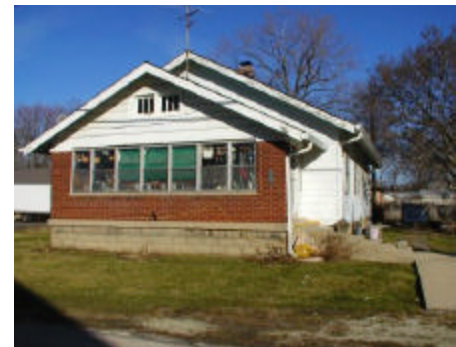
House
29 S. Starter St.
c. 1920
Contributing

Description: Characteristic of a California bungalow, this one-story house has a front-gabled roof with a front gable porch. The house has a cast stone foundation, aluminum wall cladding and Craftsman style windows. An enclosed brick front porch spans the width of the front elevation. Although the porch is currently enclosed, it was presumably originally open.

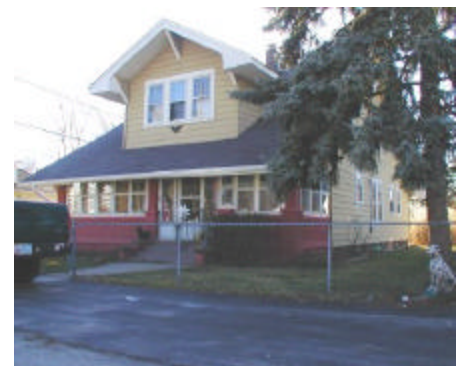
House
30 S. Starter St.
c. 1915
Contributing

Description: The character defining features of this dormer-front bungalow are the low-pitched side gable roof and the large front dormer that dominates the building’s front façade. A full-width enclosed brick porch runs the length of the front elevation. Historically, the porch was most likely open and not enclosed.

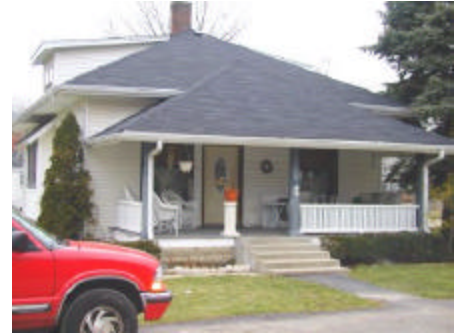
House
100 S. Starter St.
c. 1920
Contributing

Description: This 1-story pyramidal cottage features a low-pitched hipped roof with a non-original side dormer, a full-width front porch also with a hipped roof, a slightly off-center front entry door, and two large windows on the front elevation. The porch is supported by simple unfluted wood columns and accentuated by a simple wood balustrade.

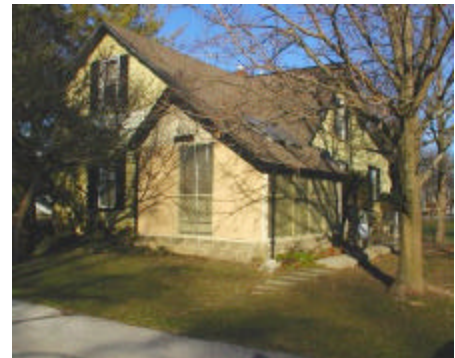
House
101 S. Starter St.
c. 1900
Contributing

Description: This 1½-story house has a modestly-pitched cross-gable roof with aluminum clad walls and one-over-one windows. The house does not appear to have a front porch, but rather an enclosed sunroom-type addition.

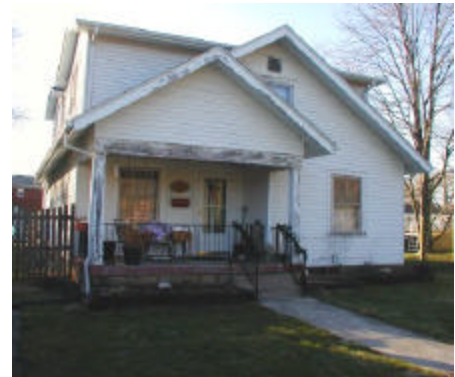
House
110 S. Starter St.
c. 1925
Contributing

Description: Historically, this house was most likely a simple 1½-story front-gable structure with a partial width front porch. The 2^d story addition, which projects beyond the original roofline of the house, was a later addition. The house has one-over-one windows, artificial siding, and a cast stone foundation.

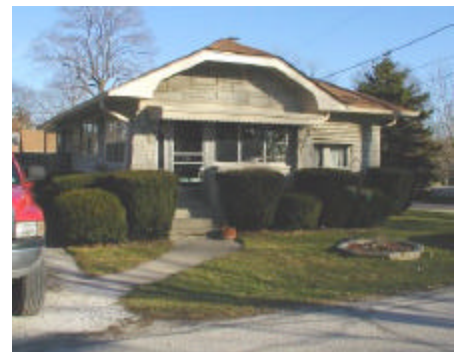
House
115 S. Starter St.
c. 1923
Contributing

Description: Built as a Craftsman-style bungalow, this house has a low-pitched hipped roof and a dominant jerkinhead front-gable that covers the partial width front porch. Also, there is a small eyebrow window on the front façade. The 1951 Sanborn map indicates this house was of wood-frame construction. It is believed that sometime after 1951, the permastone siding (an artificial masonry siding) was installed. Although the exterior wall cladding has been altered, the house retains its basic bungalow form.

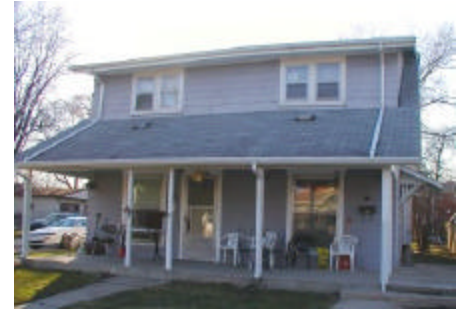
House
116 S. Starter St.
c. 1900
Contributing

Description: The architectural evolution of this house is difficult to determine. It is believed the house historically had a side gable roof with no front dormer. The shed-roof dormer is a later addition. The house has composite siding, one-over-one windows, and a slightly off center front entryway. The full-width front porch is integrated into the house and is supported by slender wood columns.

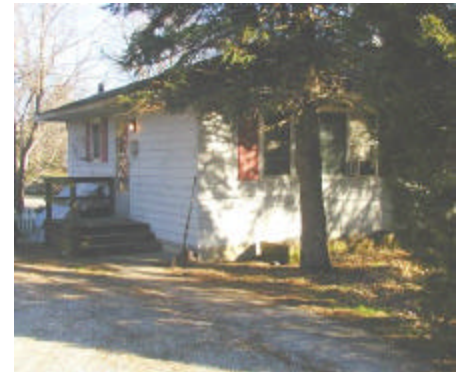
House
201 S. Starter St.
c. 1955
Non-Contributing

Description: The 1951 Sanborn maps illustrate a vacant lot. This 1-story double house has a low-pitched hipped roof, aluminum clad walls, metal windows, and non-operable shutters.

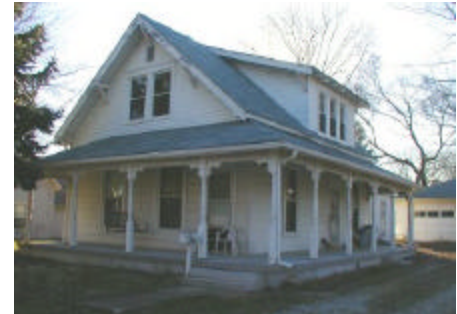
House
216 S. Starter St.
c. 1890
Contributing

Description: This 1½-story house is characteristic of Folk Victorian architecture and features a front gable roof with side dormer, wood clapboard siding, one-over-one double hung wood windows, and a porch that wraps the entire front and north side elevations. The eaves are accented by simple knee brackets and the porch is embellished with decorative scroll brackets and Queen Anne style turned porch supports. The house is an excellent example of Folk Victorian architecture and has endured very few alterations since its time of construction.

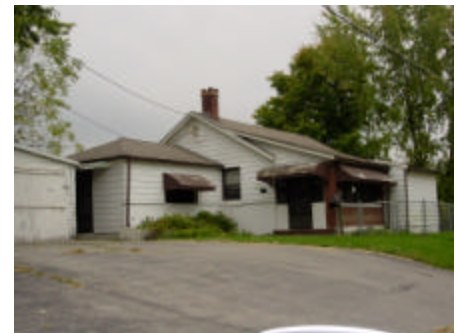
House
219 S. Starter St.
c. 1900
Contributing

Description: This 1-story house has endured several modifications since its time of construction and many architectural details were either removed or are obscured. Oriented toward Starter Street, the house has a modestly-pitched side gable roof, aluminum wall cladding, and one-over-one windows. An enclosed partial width porch is located on the front elevation. The 1951 Sanborn map indicates an open porch. Several additions were added to the house sometime after 1951.

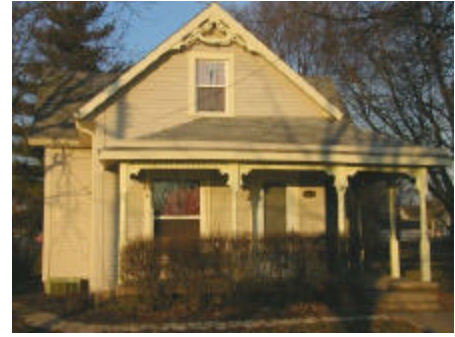
Characteristic of a folk Victorian cottage, this 1½-story T-plan house appears much as it at its time of construction. The house has a modestly-pitched cross-gable roof, vinyl clad walls, one-over-one windows, and full-width wrap around porch. Decorative Victorian-era elements are exhibited in the gable trim and the spindlework porch detailing.

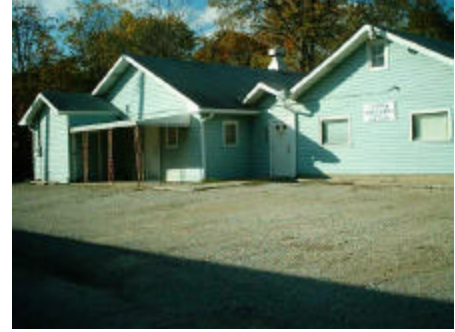
Description: Little is known about this structure, although Sanborn maps indicate that it has served commercial uses since at least 1915. The 1915 Sanborn map labels the structure as a hatchery, and the 1951 Sanborn map depicts it as a rat breeding facility. Today, it contains a drapery business.

The architectural evolution of this building is unknown, and unfortunately the building has endured some major modifications. The structure has multiple front gables, vinyl wall cladding, replacement windows on the front elevation, and some replacement doors. The rear elevation appears more intact and retains all of the original wood windows.

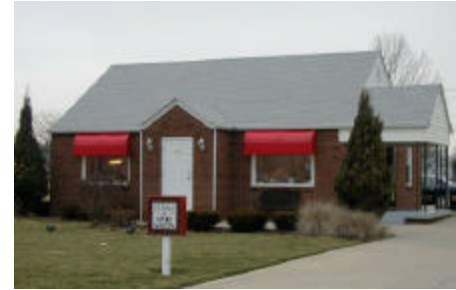
This post-war 1-story Minimal Traditional style cottage was originally constructed as a house and later converted to a commercial use. The structure has a side gable roof, brick veneer wall cladding, a small front-gabled enclosed central entryway and a small enclosed side portico. The central entryway is flanked by two large picture windows, which are accentuated by non-original awnings.

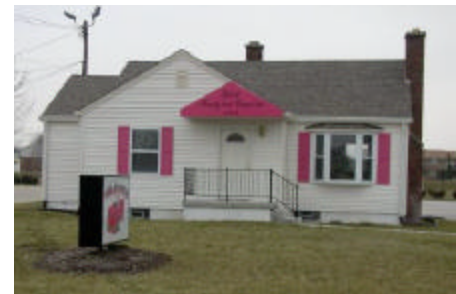
Commercial Building
11500 E. Washington St.
c. 1951
Contributing

Like its neighbor to the west, this structure is a 1-story Minimal Tradition style house that has been converted to a commercial use. The structure has a side gable roof with a prominent front gable, vinyl wall cladding, a full-height brick chimney on the east side elevation and a secondary brick chimney that projects above the roofline. There is a central entryway flanked by a one-over-one vinyl window and a bay window.

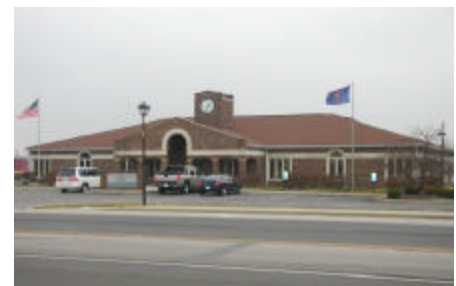
Cumberland Municipal Building
11501 E. Washington St.
c. 1999
Non-contributing

Description: The design of the Cumberland Municipal Building was adapted from a standard late 20th century church design. The 1-story structure has a low-pitched hipped roof with a central clock tower, brick veneer wall cladding, aluminum clad windows, and a central entryway with double full-view style doors.

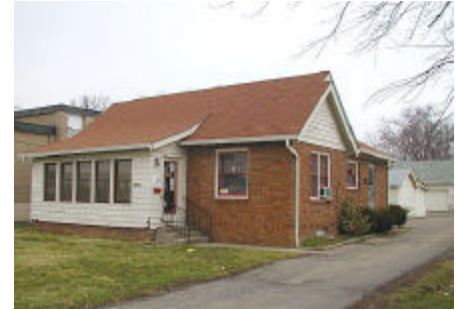
Commercial Building
11615 E. Washington St.
c.1890/c.1920
Contributing

Description: This house was converted to a commercial use in the 1920s or 1930s. Van Sickle's Tavern operated out of this building, even thru prohibition. In 1941, the building was purchased by Richard (Dick) and Orpha Miller, who owned and operated Miller's Lunch, a popular local restaurant. In 1965, Miller's Lunch closed and the structure was later sold to Sam Dodd. Mr. Dodd converted the building for a Radio & TV sales and repair shop.

Originally, this structure appears to have been a 1½ -story Queen Anne style house, which is evident by the roofline (typical hipped roof with lower cross-gables and central chimney). Sometime around 1920, the commercial-style addition was built on to the front of the house to convert the structure from a residential use to a restaurant. The front addition has a flat roof with a mansard-like overhang and numerous three-over-one double hung wood windows, some of which are have metal awnings above them. The entire structure is covered by artificial siding.

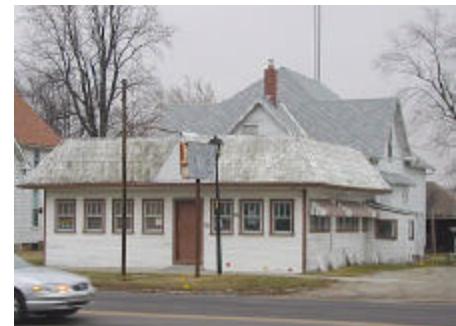
Commercial Building
11616 E. Washington St.
c. 1951
Non-contributing

Description: This structure is illustrated on the 1951 Sanborn maps as a dwelling unit. Later, the structure was converted into a commercial use and now houses a daycare center.

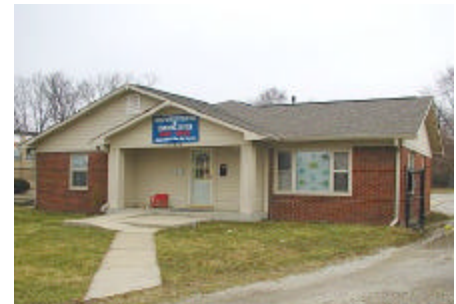
Description: The 1915 Sanborn maps show a large 2-story barn occupying this site. However, the 1956 Sanborn maps depict this structure and label it as the Telephone Exchange. Later, the structure served as the Cumberland Town Hall.

This 1-story front-gable commercial building has a front-gable roof with a narrow fascia board and cornice returns, an off-center brick chimney, and a combination of brick veneer cladding and concrete block walls. The building is simple in design and void of stylistic detailing.

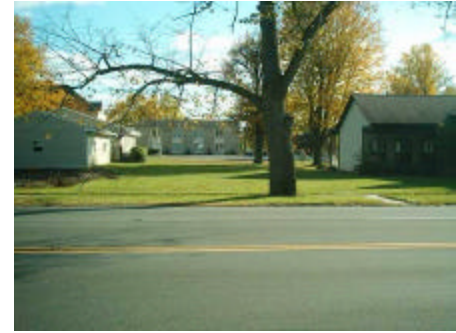
House
11706 E. Washington St.
c.1900
Contributing

Description: This house was owned and occupied by Frank and Viola Buckley, who owned Buckley's Restaurant just next door. Directly west of this house, now a parking lot, was the site of the Cumberland Methodist Church, which was demolished in the 1960's. In recent years, the house was converted for retail purposes and contains a hair salon.

Exhibiting only minimal detailing, this 1-story house has a cross-gable roof, artificial siding, replacement one-over-one windows, and a partial width brick side porch. The brick front porch is a later addition, probably added c.1915. The house most likely had a wood porch at its time of construction. An original attic vent is visible in the upper front gable.

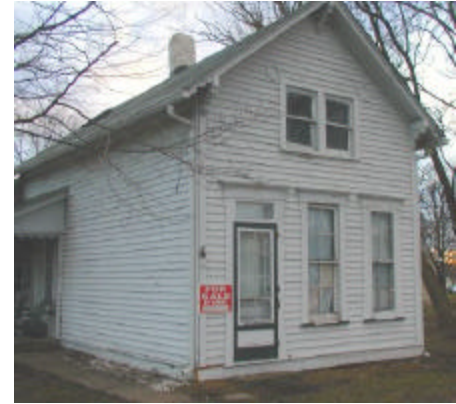
House
11801 E. Washington St.
c. 1890
Contributing

Description: In the 1980s, the house was owned and occupied by Homer and Minnie McBrayer, who also owned the house at 11807 E. Washington St.

Having minimal embellishment, this house is typical of folk Victorian style architecture. The structure has a cross-gabled roof, slight overhanging eaves with decorative scroll brackets, wood clapboard siding, four-over-four double hung sash windows, and a brick foundation. The side porch is most likely not original and the front entrance door was replaced c.1950.

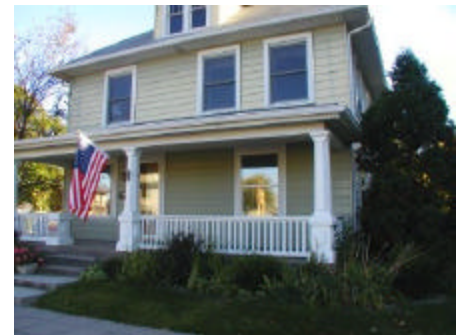
House
11900 E. Washington St.
c. 1910
Contributing

Description: John McConnell, who operated McConnell’s Grocery Store, located at the northeast corner of Muessing and Washington Streets, occupied this house at one time. The 1956 Polk City Directory indicates Mary J. Amos and a Mrs. J.B. Young also resided here.

This 2-story American Foursquare style house features a hipped roof with central dormer, a rectangular footprint, symmetrical façade and wood clapboard siding. At the time of publication, the windows were boarded, although one-over-one double hung windows are typical for this house style.

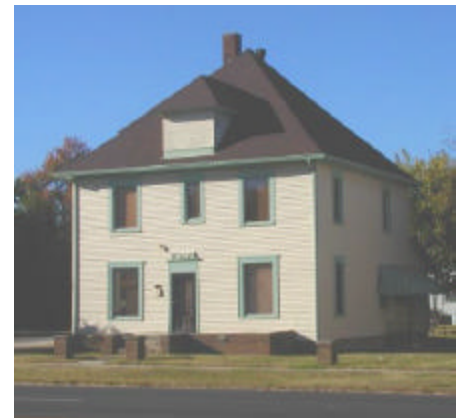
Description: City directory research states Robert G. Lombard lived here in 1956.

This 2-story gabled-ell plan house features decorative brackets and detailing that provide stylistic details to this vernacular style of architecture. Although the enclosed brick front porch is not original and was most likely added c.1920, the house retains much of its original historic fabric, including wood clapboard siding, two-over-two double hung wood windows, decorative scroll brackets, attic vents, brick foundation and brick chimney.

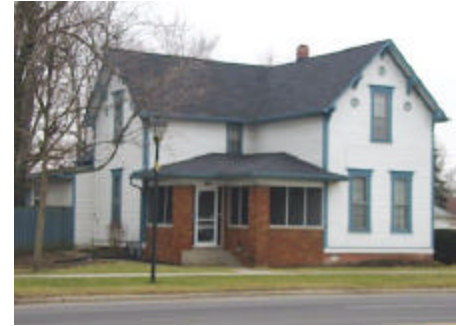
House
11909 E. Washington St.
c. 1880
Contributing

Description: The 1956 Polk City Directory indicates Charles T. Gibson lived in this house.

Since its time of construction, this 1½-story house has experienced significant alterations. The structure has a cross-gabled roof, vinyl wall cladding, and vinyl windows. The original size, scale and massing were altered with the construction of the rear addition, which projects above the original roofline of the house, and the original window and door openings have been changed. Also, the structure currently has no porch, which is atypical for houses of this era.

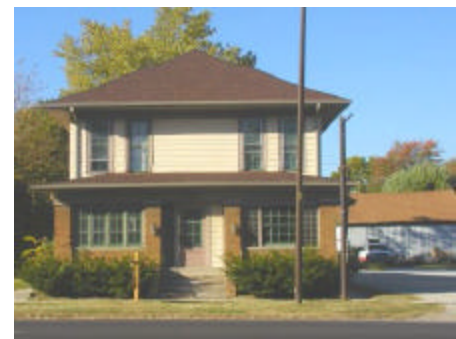
Description: This site was historically occupied by 2 structures. The infamous Little Hotel once stood right at the corner of Starter St. and the National Road. The Little Hotel was a 2-story frame I-house, with a symmetrical façade and a double porch. Also on this site was a 1-story frame shop that had an open 1-story porch. Both structures are depicted in the 1951 Sanborn maps.

The existing structure has a very low-pitched hipped roof with a ridge, brick veneer wall cladding, and two typical storefront entrances.

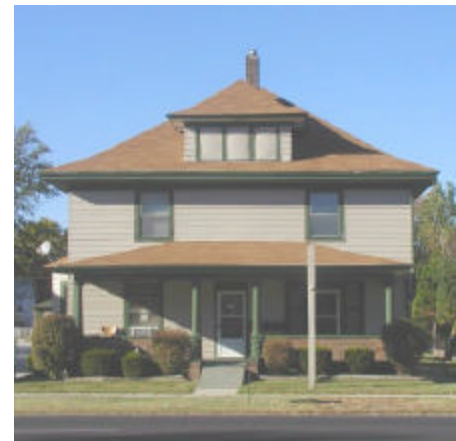
House
11924 E. Washington St.
c. 1915
Contributing

Description: Although the dates are unknown, Harry Wray and wife resided here. The building also served as one of Cumberland's telephone exchanges.

This 1½-story gable-front house has a modestly-pitched roof with two side dormers, vinyl wall cladding, and one-over-one windows. A full-width enclosed brick porch spans the front elevation. Although the front porch is currently enclosed, it was most likely open when it was first built.

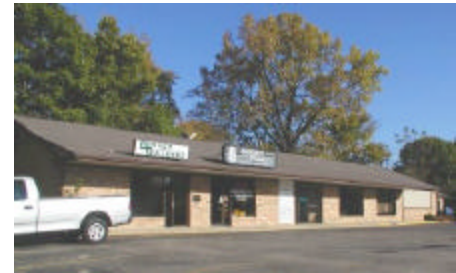
Commercial Building
12010 E. Washington St.
c. 1951
Non-Contributing

Description: This structure was built around 1950 by Henry Meirs, who owned and operated Meirs Grocery Store. Historically, the 2-story American Foursquare house at 23 N. Starter St. occupied this site, but was moved to its current location to make way for Mr. Meier's grocery store. The structure was later Guidone's Store and then Kroetz Drug Store.

This 1-story commercial building has a very low-pitched gable roof and concrete block walls that are accentuated by a honeycomb pattern on the front façade.
